ShLOW! Show Me How Slow

Final Report

Kyriakou Nikodimos

Lefteris Sdoukopoulos

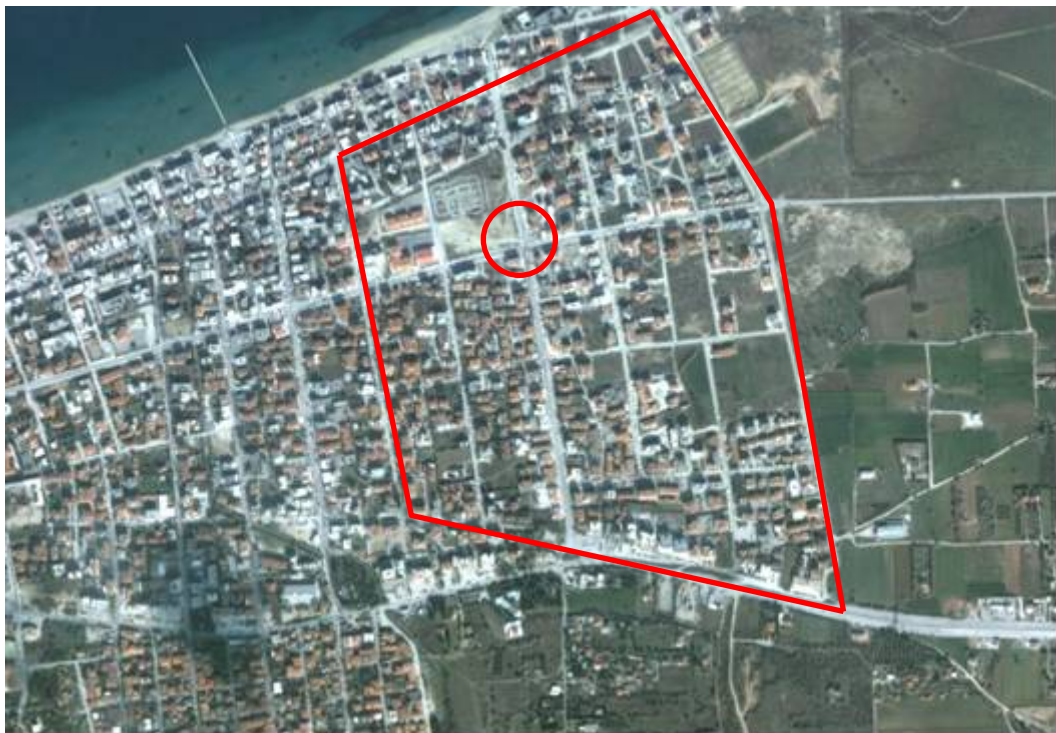
Figure 4.2 Zone of the city expansion

The surrounding area consist of newly build apartment blocks that housed great part of former Thessaloniki residents that moved south and east for better living conditions. Figure 5.3 shows the rate of increase of the areas population between 1991 and 2001. The high number of accidents is, at a great part, depended on the fact that both streets are newly made.

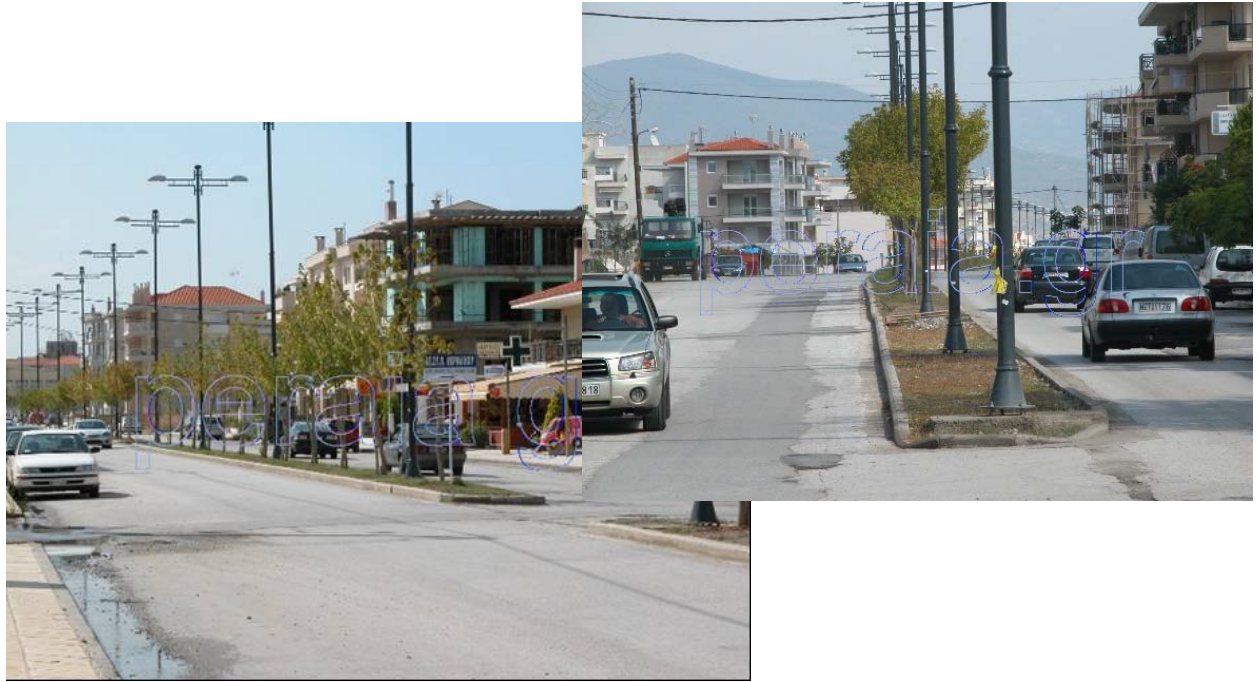
Figure 5.2 Pictures of Antheon Street

As shown in the later figure both Antheon and Filippou street are two-way streets with a separating islet in the middle. The width of Antheon street is between 7 to 8 meters per direction. Moving on Antheon street has the priority when entering the intersection. For the above reasons many times high speeds are observed.

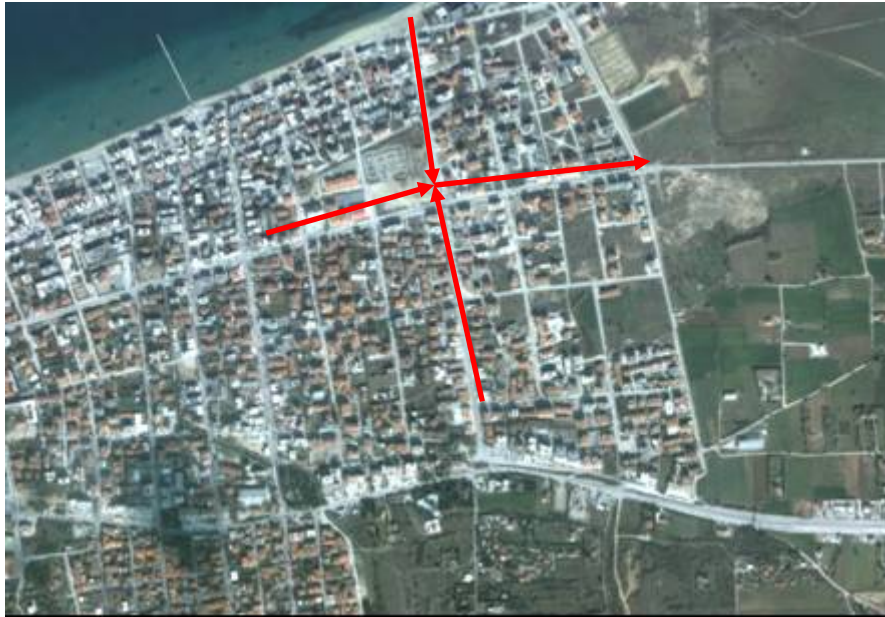
Figure 5.3 Traffic diagram of the area

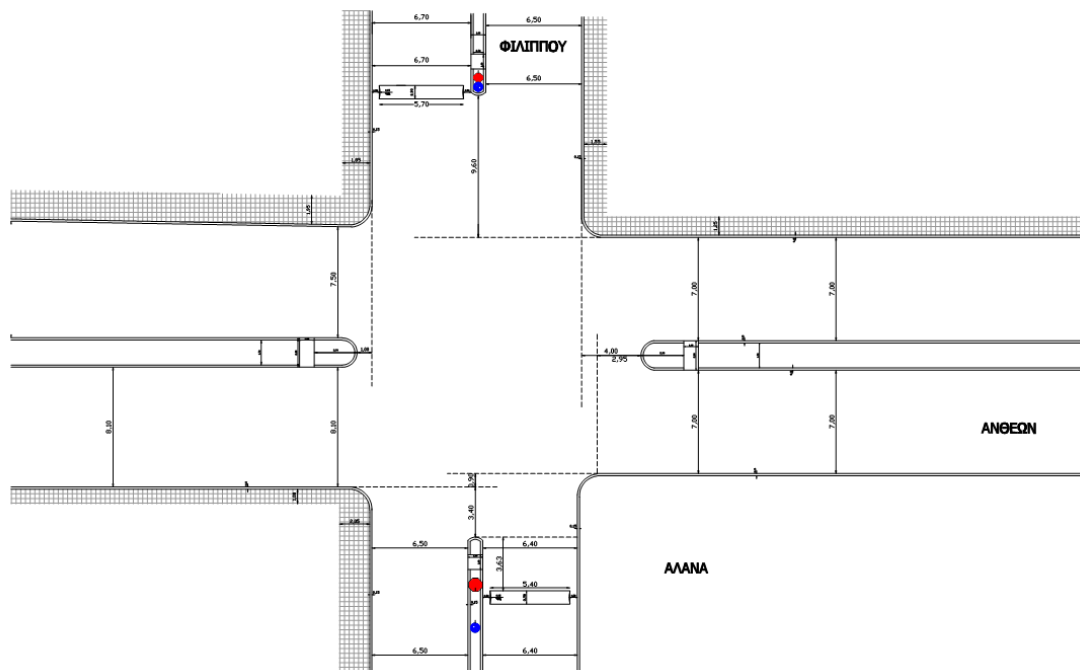
In order to decide the proposed measures certain methodological steps were taken. The first step had to do with the mapping of the current road status. As there was no reliable topographic drawing of the intersection, a draw was produced. At figure 7.1 the current situation is shown.

Figure 7.1 Current situation drawing

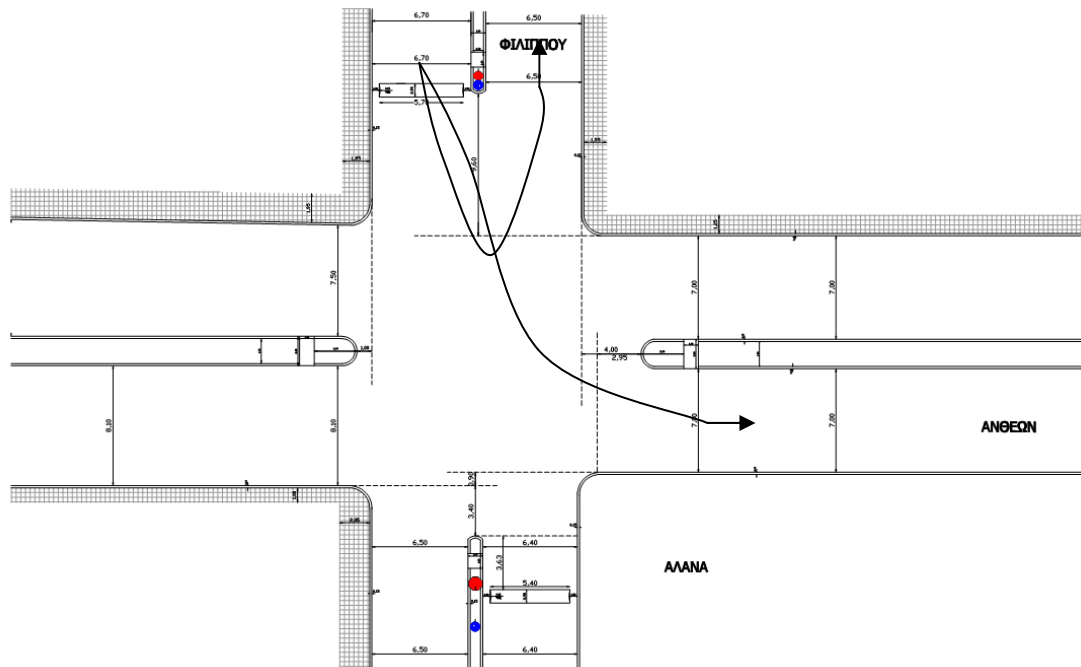
Intersection geometry seemed to be problematic mostly at the higher section of Filippou street. As the islet is short in order to leave space for the public transportation bus to turn left safely, the U turn is almost allowed to vehicles.

Figure 8.1 High speed left turn and U-turn

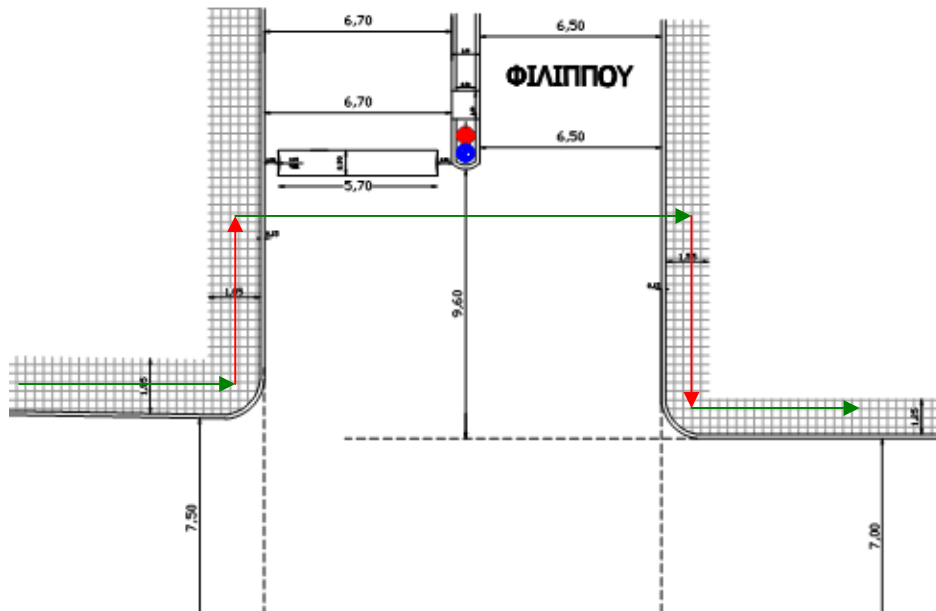
Moreover safe crossing for pedestrians, and most important students of the nearby high school, had to include 9+9 meter bypass, something that rarely happened.

Figure 8.2 Pedestrian crossing

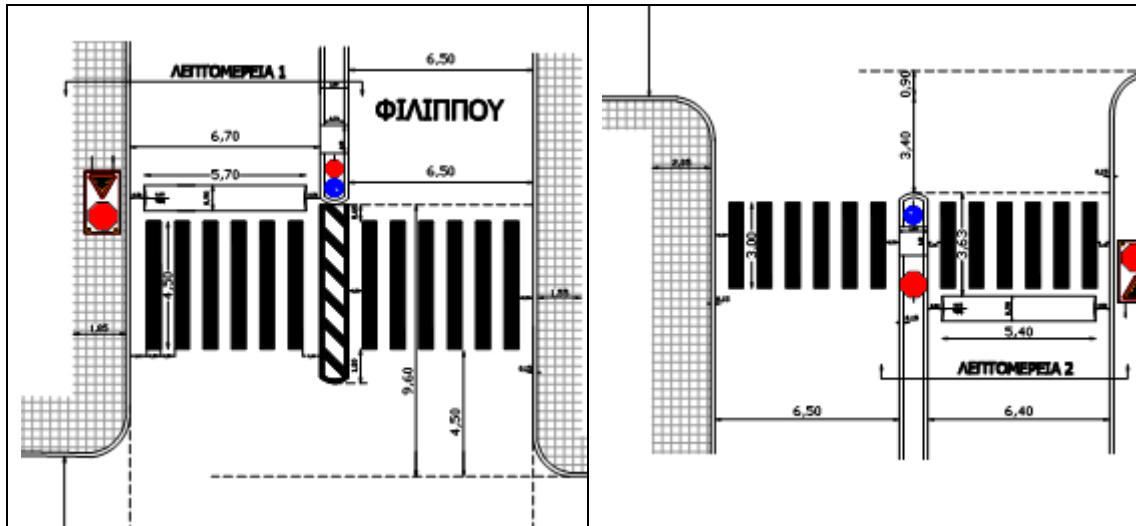
Horizontal signing proposals included zebra crossings for pedestrians. The previously installed "humps" would remain in their former position as their impact was mostly positive. The lack of islet of the upper section would be replaced with proper signing in to make the passage from pedestrians safer, as they could stop in the middle of the crossing to check for vehicles in the other direction.

Figure 9.1 Suggested horizontal signing

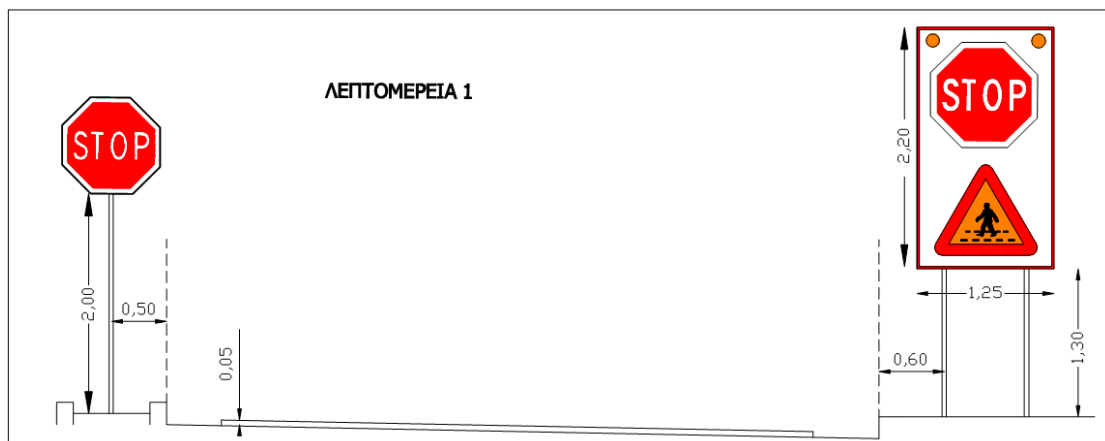
Vertical signing would include additional stop signs on the right part of the streets. There would also be flashing orange lights on the combined “stop” and “pedestrian crossing” signs.

Figure 9.2 Suggested vertical signing

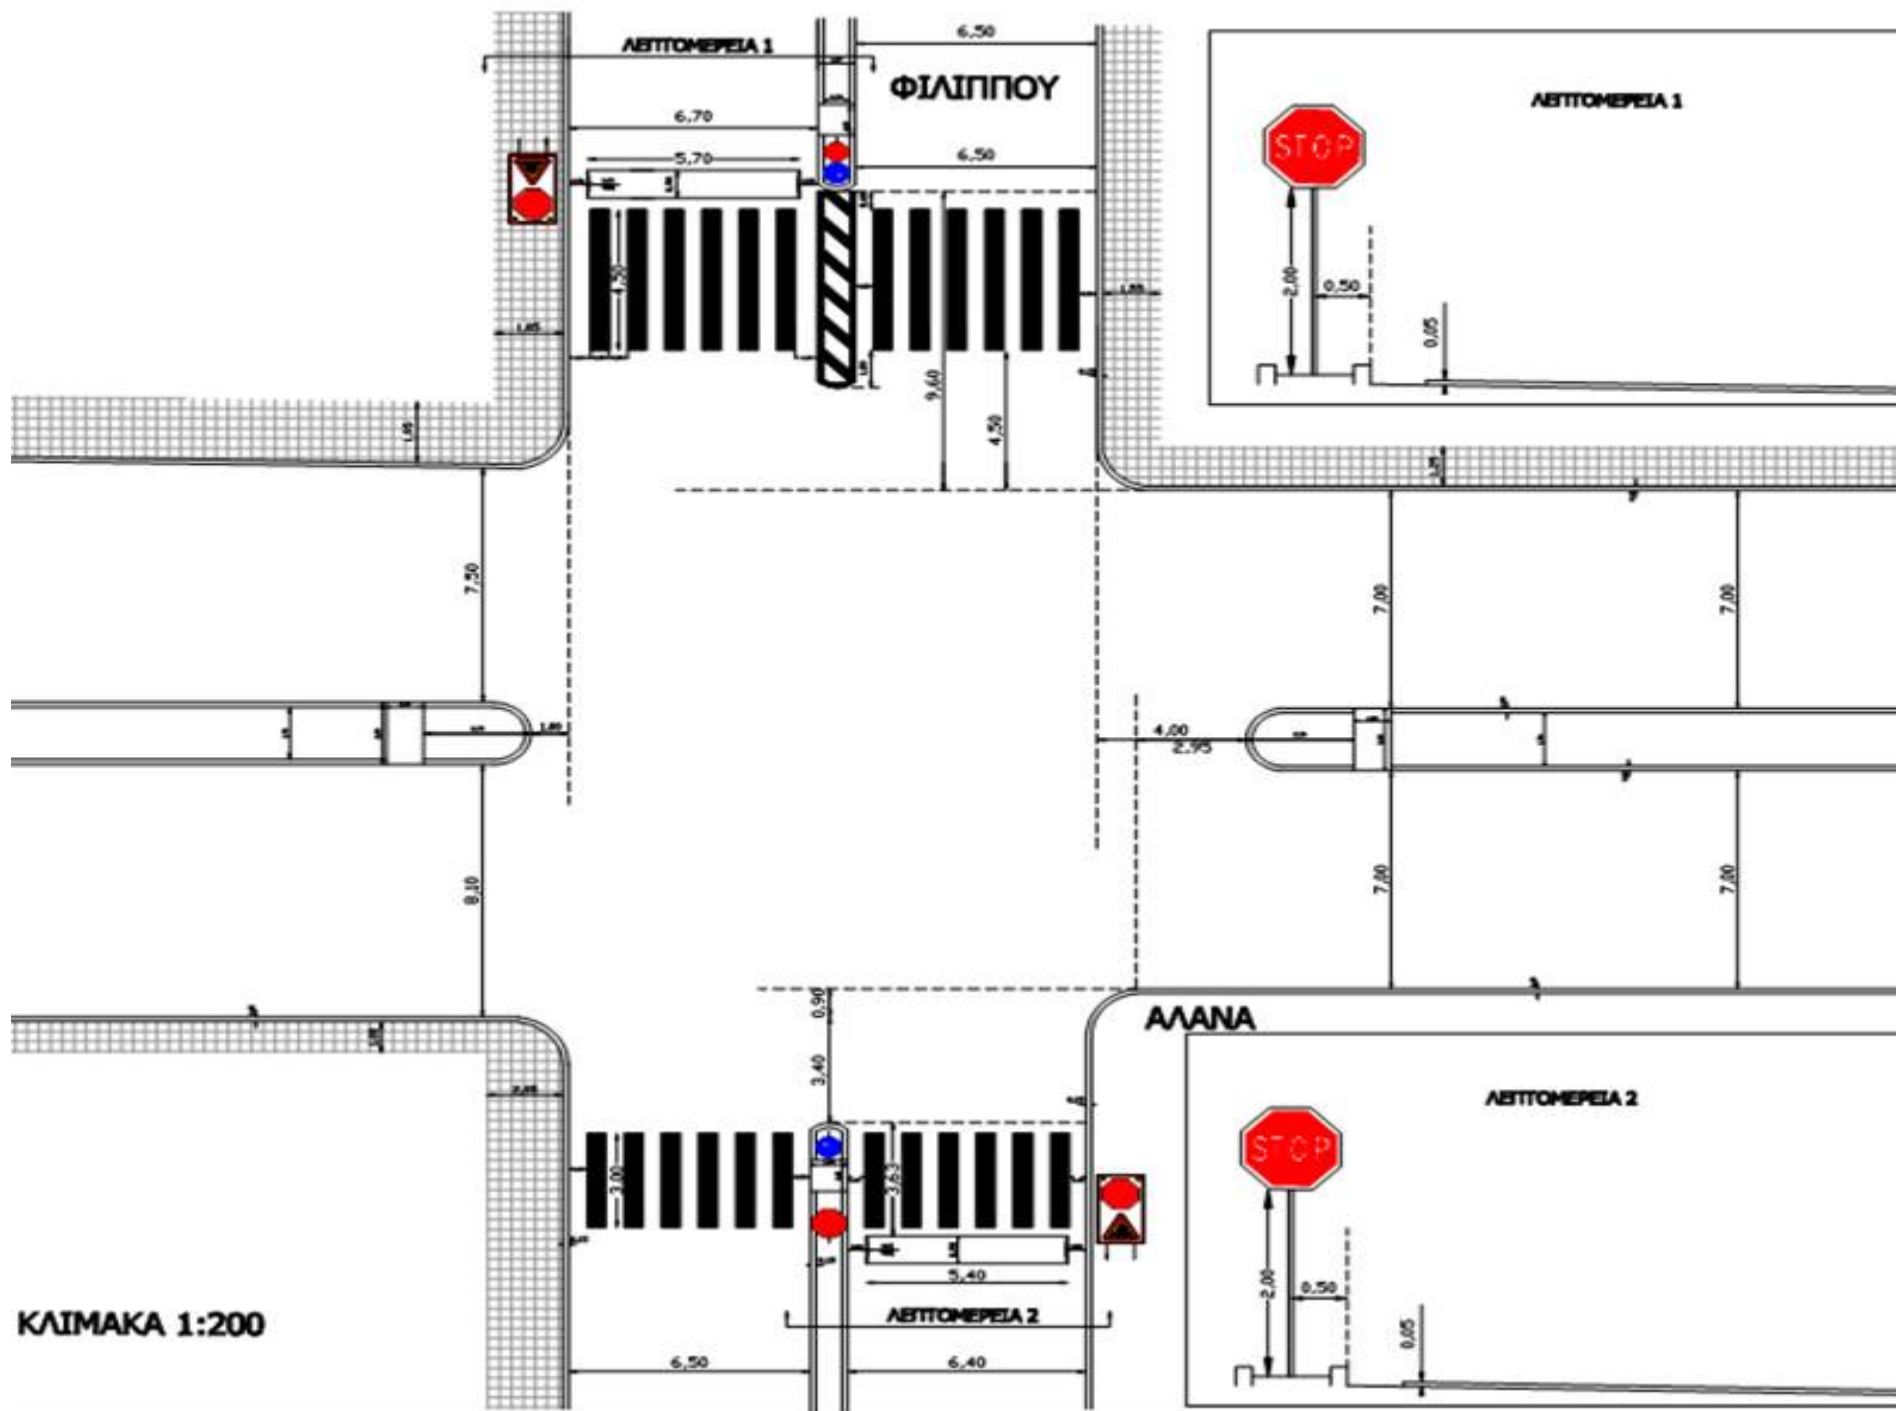
The final proposal is showed in the following map. In order to install the vertical signs and to succeed their target, many shop’s Billboards of the Filippou sidewalk must be taken away. This was the main problem that occurred and the main reason for the municipality authorities for not implemented the signs on time in order to have the final results of our intervention.
